Manhole Inspection Summary

Manhole # **S19G__061MH**

Insp Date: **8/10/09 2:33 PM**

Location Address: **BEHIND 1 N BENTALOU ST** Cross Street: **W BALTIMORE ST**

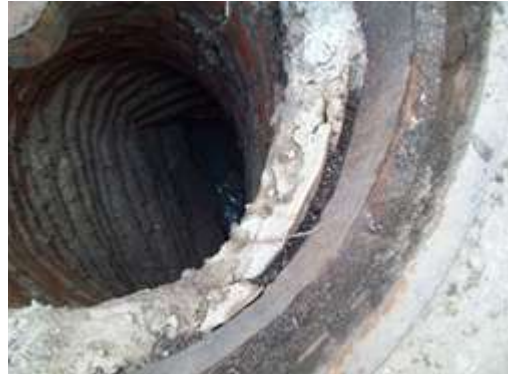
Defect 1

Frame Offset: **3** (in.) Condition: ☒ Sound ☐ Cracked ☐ Leaks

3" OFF SET FRAME

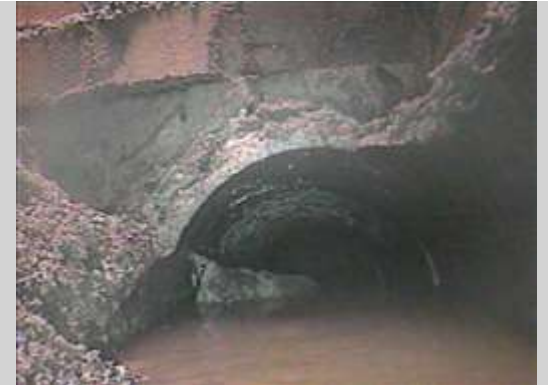
12 O'Clock Outflow

8 in. Circular Gravity Sewer
Pipe Out @ 12 O'Clock

Pipe Height: (in.) Direct
Pipe Material: **Clay** ☐ Pipe Lined
Invert Depth: **6.05** (ft.) Flow Characteristics: **Slow**
Deposits: ☒ None ☐ Mud ☐ Sludge ☐ Debris ☐ Grease
Silt Depth: (in.) Deposits Extent:
Infiltration: **None** Pipe Seal Cond: **Sound**

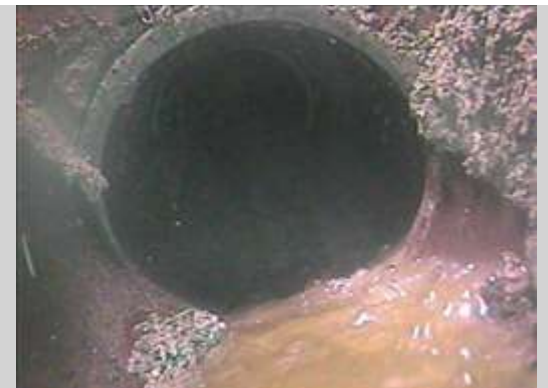
6 O'Clock Inflow

8 in. Circular Gravity Sewer
Pipe In @ 6 O'Clock

Pipe Height: (in.) Direct
Pipe Material: **Clay** ☐ Pipe Lined
Invert Depth: **5.85** (ft.) Flow Characteristics: **Slow**
Deposits: ☒ None ☐ Mud ☐ Sludge ☐ Debris ☐ Grease
Silt Depth: (in.) Deposits Extent:
Infiltration: **None** Pipe Seal Cond: **Sound**
